THE INTRODUCTION AND USE OF COPPER SHEATHING - A HISTORY

Mark Staniforth

The copper sheathing and fastenings of the American China trader *Rapid* (1812)

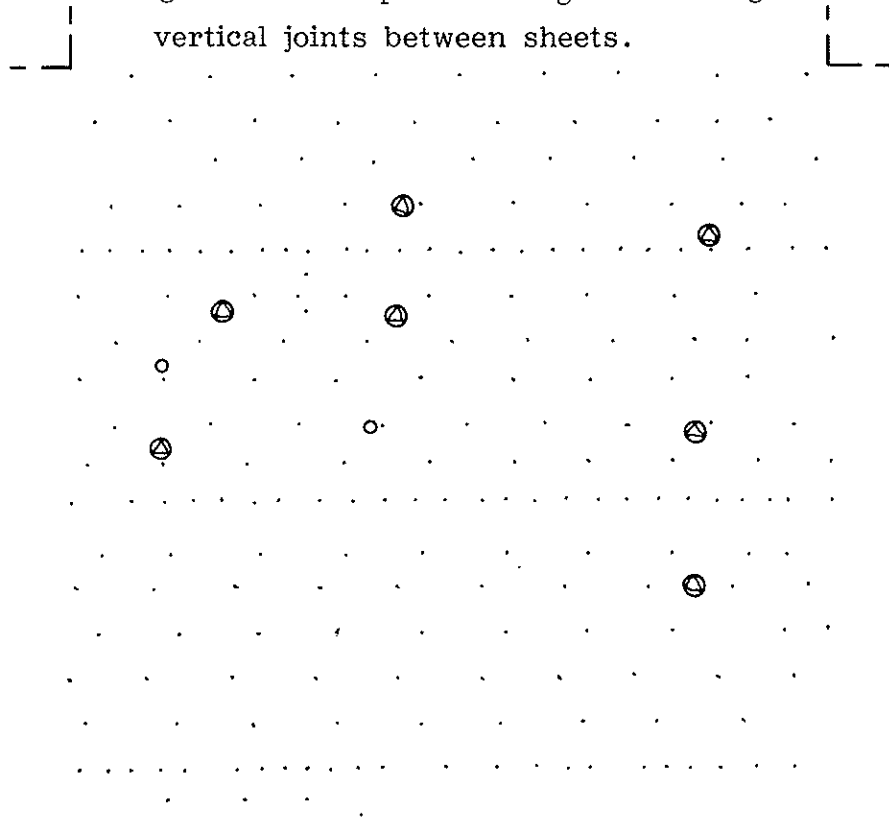
Fig. 8 Nail pattern diagram showing vertical and horizontal joints.

In order to accurately determine the position of the vertical joints between the copper sheets it was necessary to measure a third area of the copper sheathing. This proved most successful, with the horizontal and vertical joints being clearly visible. The area chosen for these measurements was less than 1 m in height because the planking above the 85 cm mark on the vertical tapes was broken and showed signs of severe teredo attack (Fig. 8).

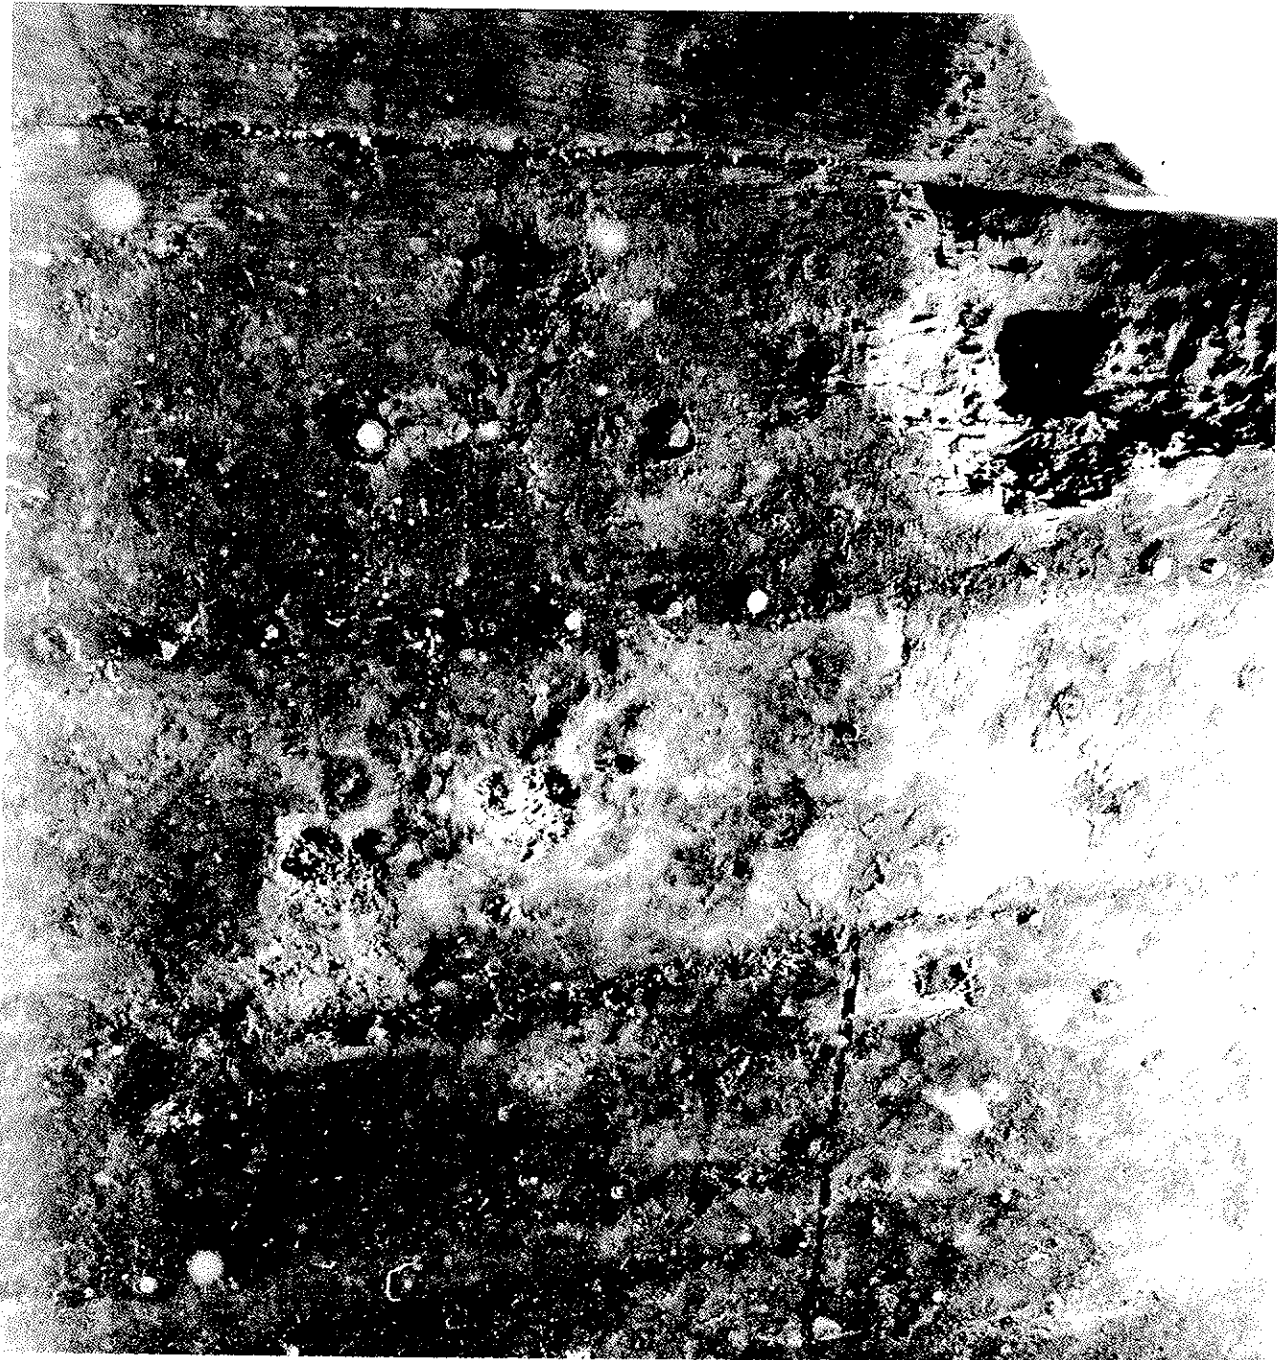
Fig. 9 Photograph showing outer planking with rows of copper sheathing tacks clearly visible.

Figure 9 shows part of the area of hull used to obtain the above results.

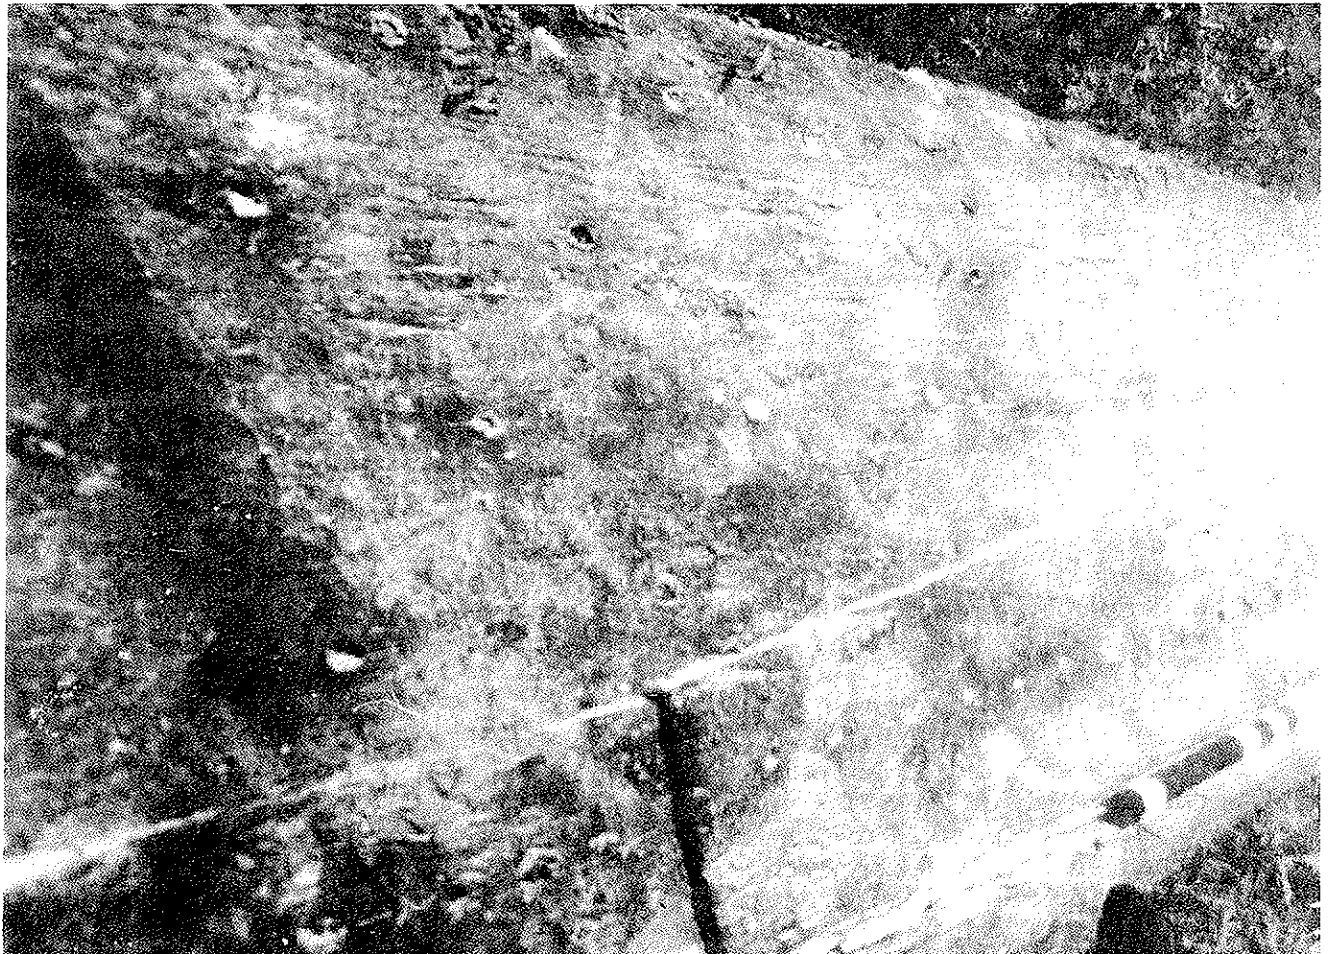
Fig. 13 Photograph of the keel, outer planking and false keel showing the keel joint.

The keel was 45 cm deep and made up of timber of two heights: the upper section was 22 cm high and the lower section 12 cm high. The keel with the outer planking above and the false keel visible below, can be seen in Figure 13. The joint in the lower timbers can be clearly seen together with the horizontal row of copper tacks attached to the copper sheathing which went under the keel.

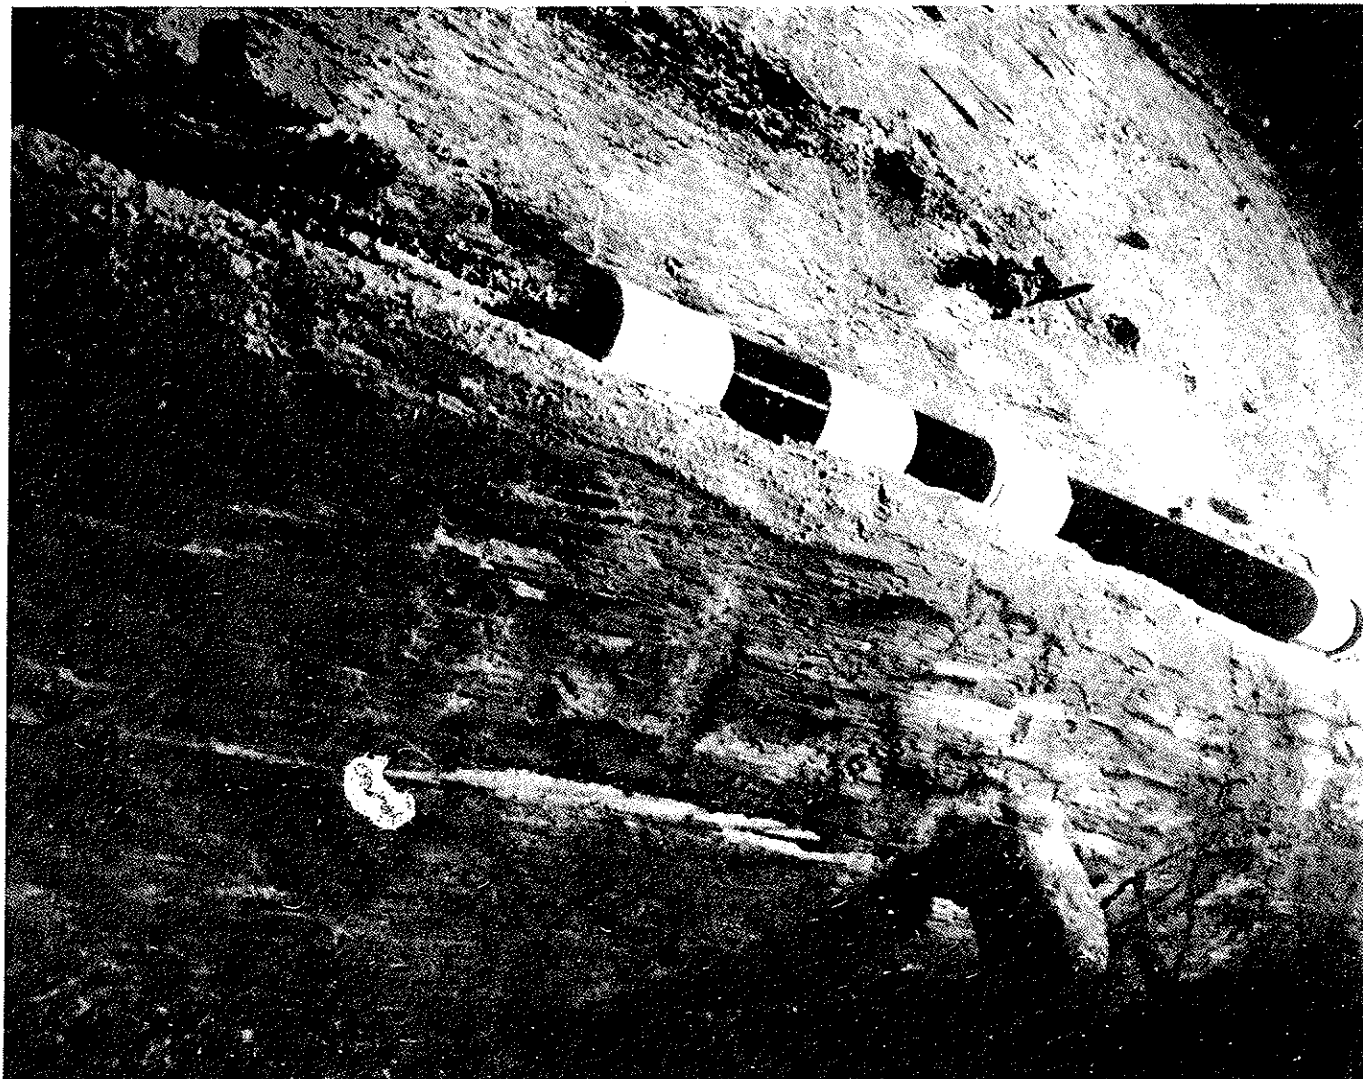
Fig. 14 Photograph of the false keel showing false keel fastenings.

The row of copper sheets over the base of the keel were placed over a thick layer of felt to cushion the false keel against the keel. The false keel was made from a roughly cut half of a tree trunk and was secured to the keel by means of 3 cm diameter copper bolts. Figure 14 shows the false keel with the scale in the join between the keel and the false keel and one of the false keel bolts appearing in the bottom right of the photograph.

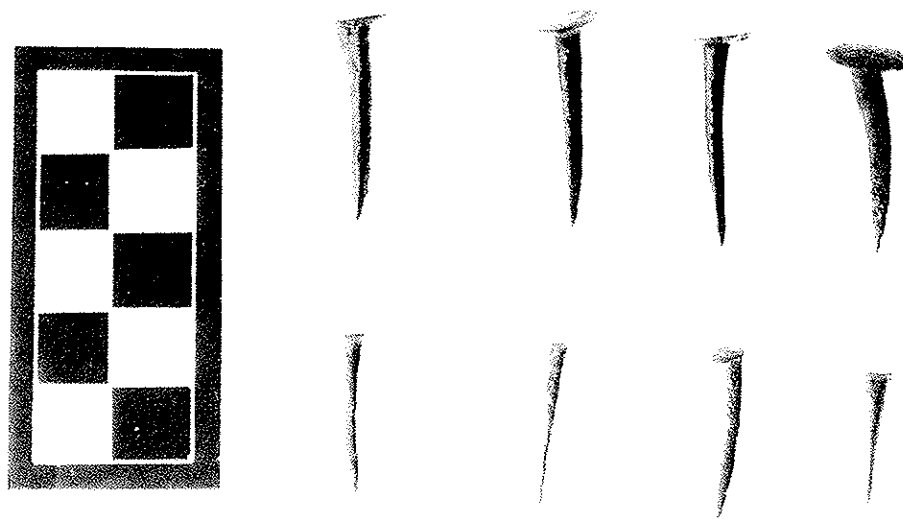
Fig. 15 Photograph of copper sheathing tacks.

Many hundreds of the copper sheathing tacks from the *Rapid* have been recovered during the four seasons of excavation. Originally each tack would have been 3 cm in length, with an irregularly circular head and a tapering square or round shank. The diameter of the head is approximately 1 - 1.25 cm and the shaft less than 0.5 cm in diameter at the head tapering to a square faceted point. Many of the copper sheathing tacks were broken at the junction between the head and the

shank of the tack. This is caused by differential corrosion rates; the corrosion of the tack in the area between the copper sheet and the timber being a more rapid form of corrosion (Ian MacLeod, pers comm). Figure 15 shows copper sheathing tacks with the top row of tacks being close to original size while the bottom row shows signs or corrosion, in some cases severe.

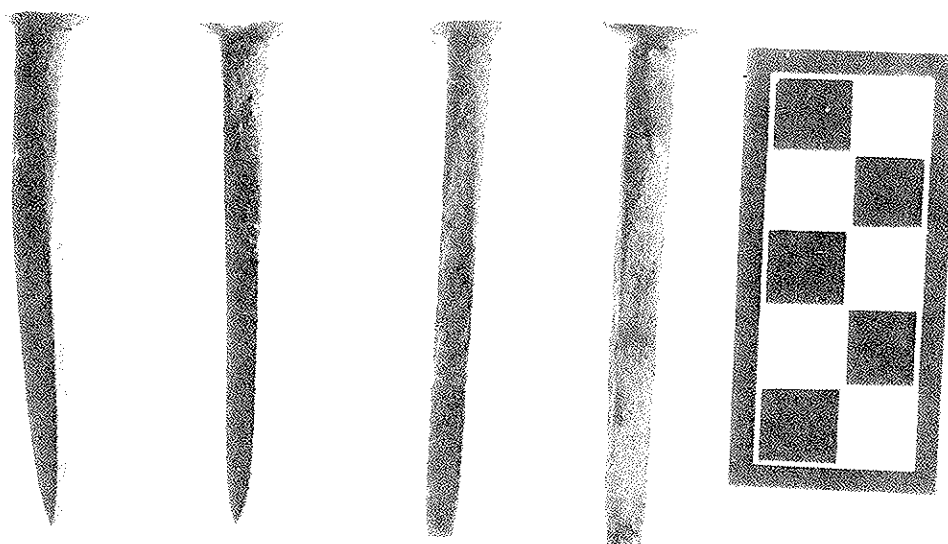
Fig. 16 Copper nails used to fasten sacrificial planking to outer hull planking of the hull.

Figure 16 shows copper nails which held the pine boards (sacrificial planking) used above the waterline in place of copper sheathing.

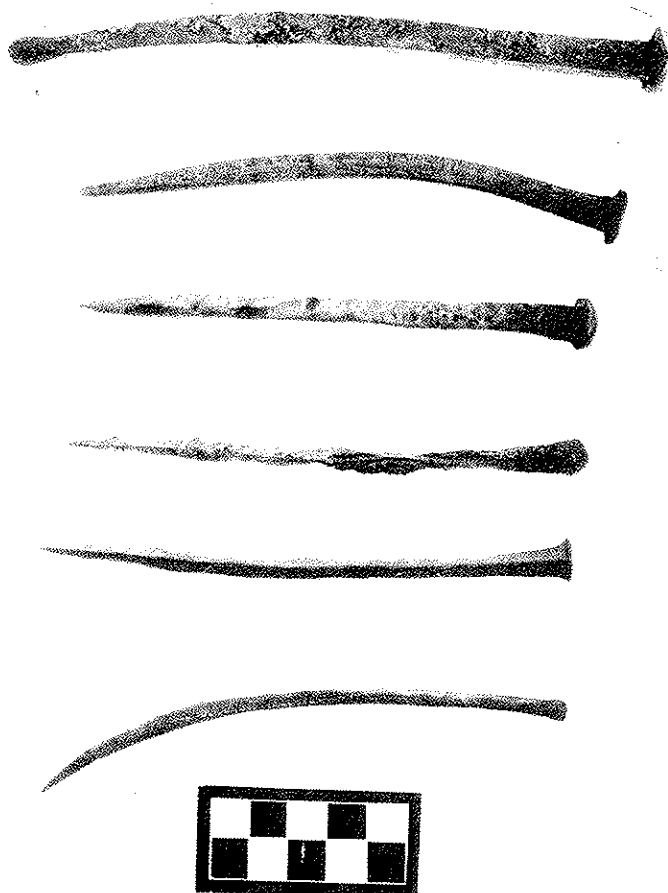
Fig. 17 Photograph of copper spikes, some showing severe corrosion.

Figure 17 shows a number of copper spikes from the *Rapid* with the one on the extreme left being from the stores and is in an unused and uncorroded condition while the others show signs of severe corrosion.
